Saboteurs hit Maputo's power

The repeated sabotage of the transmission lines carrying electricity from South Africa to Maputo deprived the Mozambican capital of its normal source of power for a total of 53 days in the first four months of 1990.

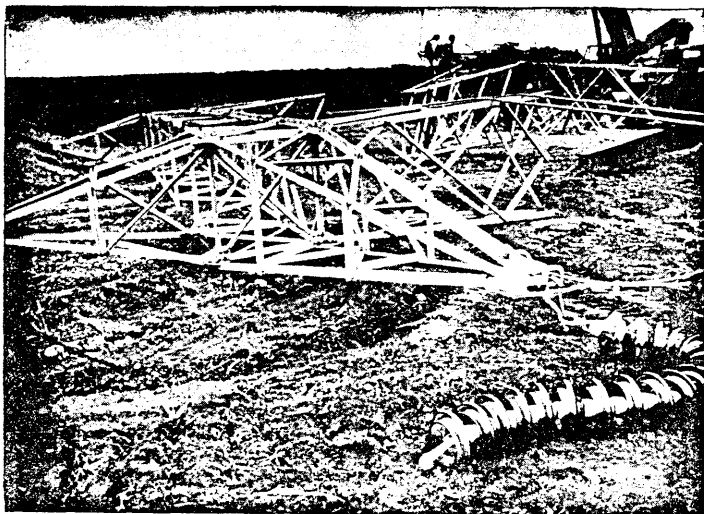
The pylon blown up on 14 May, lies on its side at Tenga, 25 kilometres outside Maputo (AIM/Antonio Muchave)

There was a respite in May, with just one attack on the line, on 14 May, when a pylon 25 kilometres from Maputo was blown up.

This particular pylon was about 70 per cent damaged. Those parts must be replaced, and welded onto the 30 per cent that is still intact. The heavy engineering factory Cometal-Mometal is now producing pylon parts specifically for this work.

The most recent attacks on the line have occurred at dead of night. This particular pylon was knocked down at about 03.00 in the morning. Mr Sultuane says Renamo uses specialised groups of no more than four men to blow up the pylons. The normal method used is to place a charge of plastic explosive on each of the four legs of the pylon, either at the base or a metre or so above ground level.

In mid-May EDM witnessed a team of electricity workers repairing the pylon damaged in the 14 May sabotage. According to Fuade Sultuane, head of EDM's transmission department for its southern region, the 21 workers involved are highly experienced - they are the same group that has been repairing sabotaged pylons since 1985.

The team works throughout the hours of daylight. "If a pylon isn't too badly damaged, it takes about three days to repair", says Mr Sultuane. "If it's completely wrecked, it can take between seven and eight days".

Before any pylon can be repaired, precautions must be taken to clear any mines left by the saboteurs, and then EDM often has to use bulldozers to clear a path through the bush to reach the site of the sabotage.
