Don't be led astray by the

Robert Kirby argues against the theory that South Africans lured Mozambican president Samora Machel to his death

'decoy beacon' theory

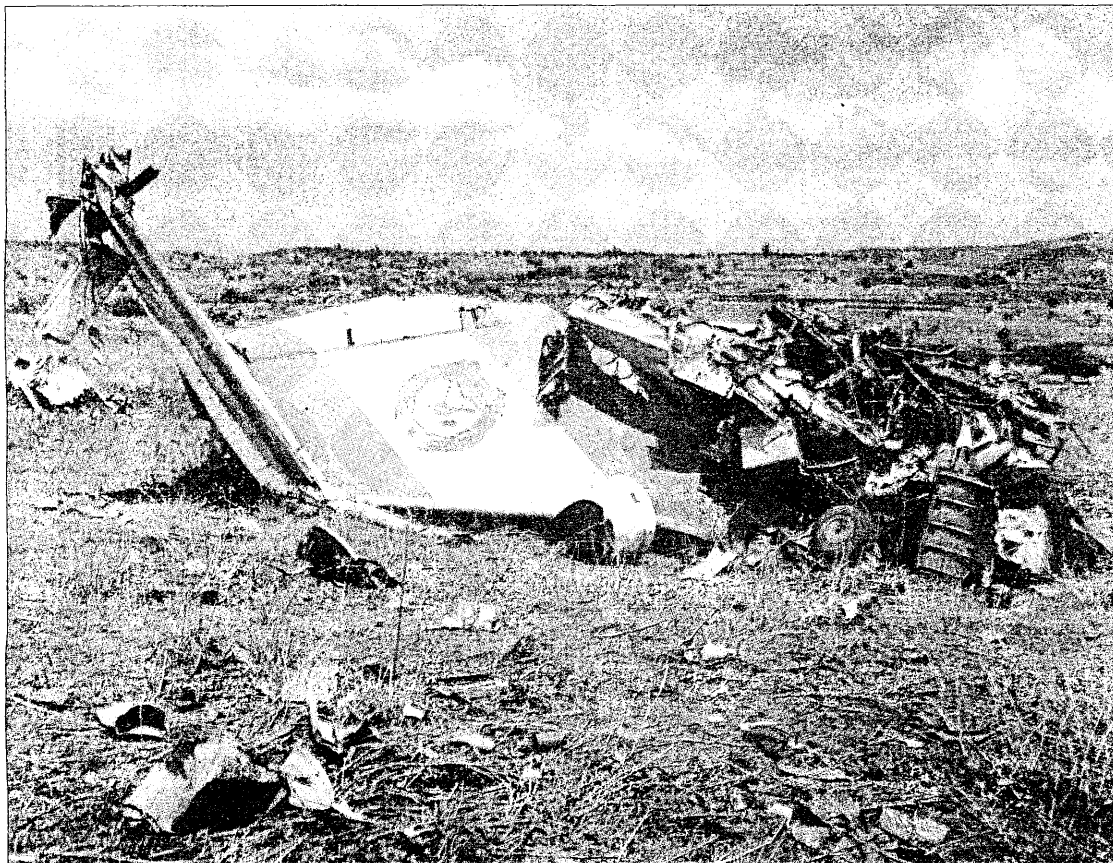
Disaster zone: Circumstances made the fateful crash 'a juicy steak for speculation'. PHOTOGRAPHS COURTESY RAPPORT

The accident had occurred 150m inside South African territory. The aircraft's passengers included the president of a neighbouring and, at the time, politically antagonistic state; destabilisation of the sub-continent was conspicuous in the political agenda of the South African government. All in all a juicy steak for speculation.
